CRITERIA OF REPLACEMENT STATE OF THE WIRBELSTAR

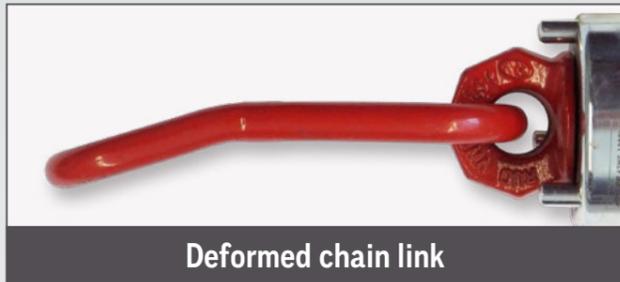
Deformed chain link

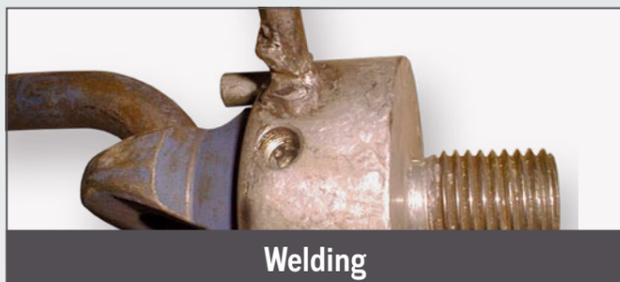
Welding

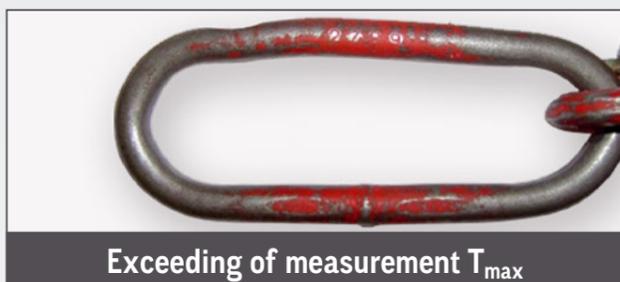
Exceeding of measurement T_{max}

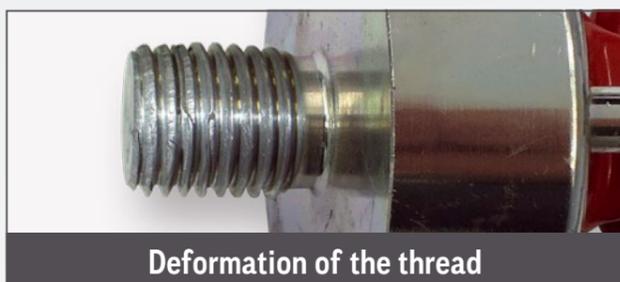
Deformation of the thread

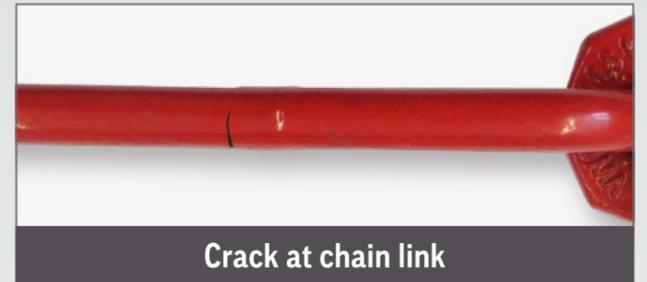
Crack at chain link

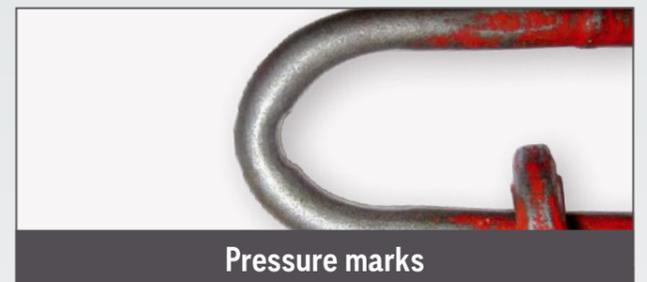
Pressure marks

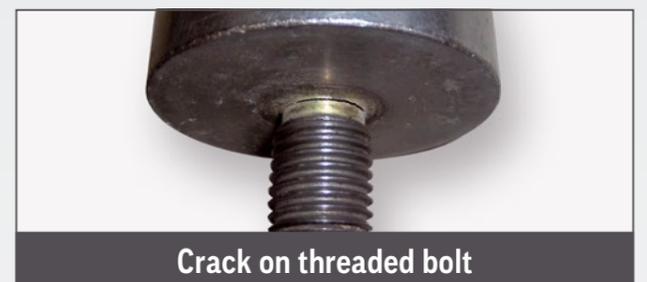
Crack on threaded bolt

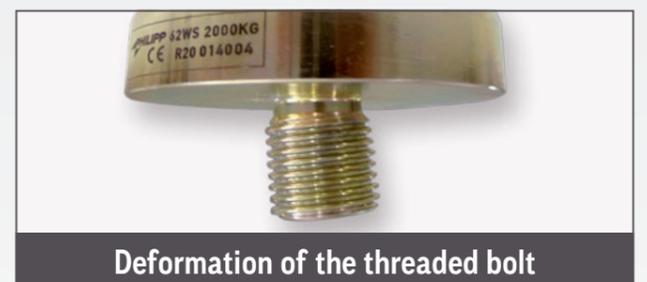
Deformation of the threaded bolt
